Comparing Common Heat Treatment Options for Tapered Roller Bearings

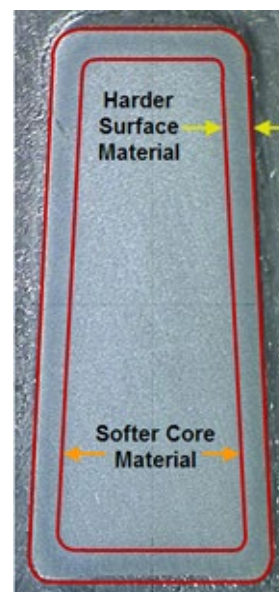
Figure 2: Case-Hardened Roller

Case hardening (also known as carburizing) is a type of heat treatment commonly used for tapered roller bearings, which provides superior resistance to fracture under impact loading. In the case-hardening process, lower carbon steel is heat treated in a furnace with a carbon-controlled atmosphere. It remains in the furnace for a period of time to allow the carbon to be absorbed through the surface of the steel to a predetermined depth. This forms a hard, high-carbon surface layer necessary for the rolling contact surface, while the core remains relatively soft. The softer core is able to better absorb shock loading, making the bearing less prone to fracture under impact.

In addition to improving impact resistance, the softer core improves performance under misaligned conditions and carburized material generally improves bearing fatigue life by 40%. For these reasons, case-hardened steel is the standard for every NTN-Bower bearing. In the study shown in **Table 1** on the back side of this document, a premium NTN-Bower carburized bearing demonstrated its advantage over competitor through-hardened bearings when tested under set radial and axial loading conditions, where the carburized bearing exhibited L10 fatigue life that was 50% higher than Competitor A and 413% higher than low-cost Competitor B.
