NTN's Sealed Ball Bearings Halve Maintenance on Bag Seal Checking Line

CS-1734

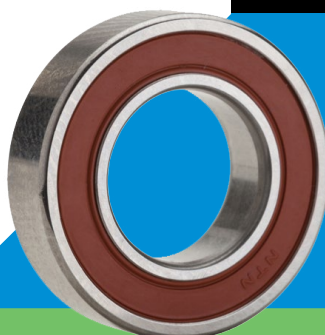
Figure 1

Grooved Type Sealing Figure for Excellent Performance (All Models)

A v-shaped groove is cut around the inner ring. Under centrifugal force, the outer surface of the 'v' acts to keep out dirt; the inner surface of the 'v' acts to seal in the grease.

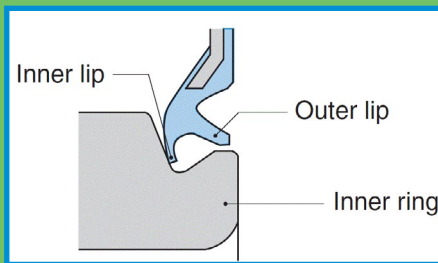
Figure 2

Double-Lip Seal Adjusts to Wear (LLU Spec)

The inner lip of a double-lip seal is pressed against the inside surface of the V-groove; the outer lip is spread open by the elastic force of rubber to create a small gap between the outer lip and the inner ring, creating a labyrinth effect (Figure 2). Should the inner lip wear, the contact pressure will decrease; however, the outer lip will get closer to the inner ring (Figure 1). In effect, a constant degree of sealing will be maintained; and, as a result, bearing service life will be noticeably lengthened.
